Assessment of Dam Safety of Coal Combustion Surface Impoundments

Hugo Power Plant

Western Farmers Electric Cooperative
U.S. Highway 70
Fort Towson, Oklahoma

Final Report

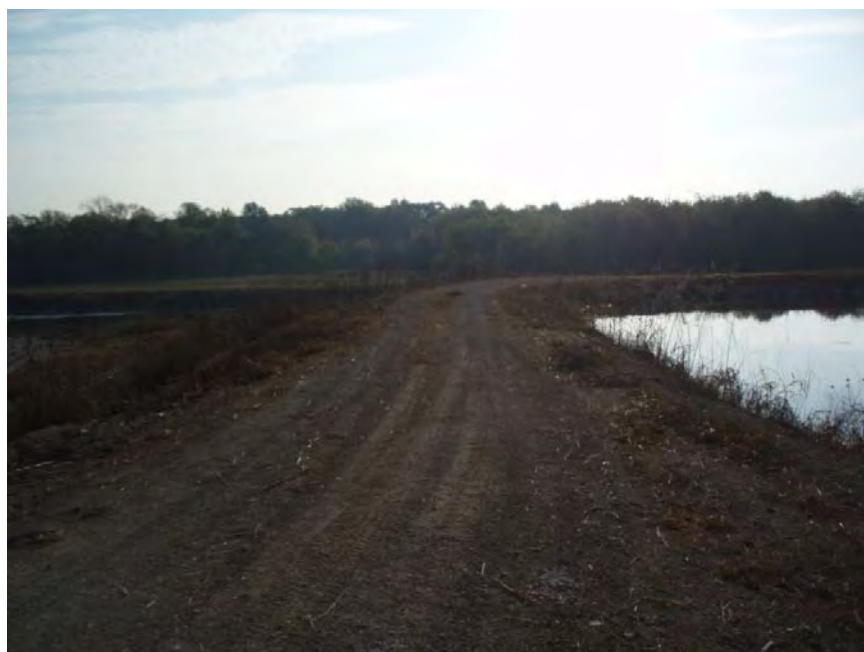
The crest width is about 10 feet on the east, south, and west sides, and 25 feet on the north side. The entire crest is subjected to vehicle traffic, though the majority is restricted to the north and east embankments. The crest surface appeared to mainly consist of compacted granular material and vegetation. The crest appeared to be in satisfactory condition (Photographs 2 and 7).

2. South Bottom Ash Pond - Looking toward east embankment crest embankment?

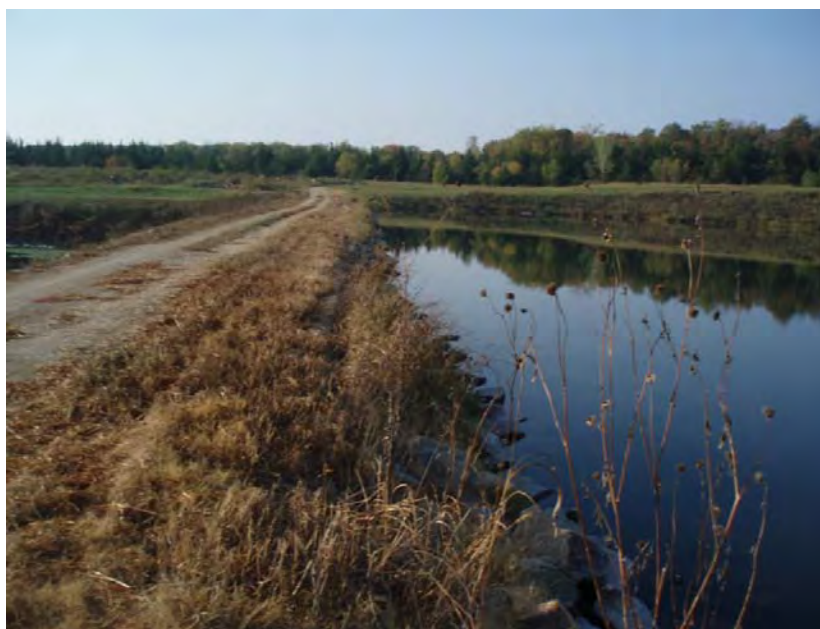
The interior slopes were approximately 2H: 1V. Riprap armoring of the interior slope is present on the east embankment (Photographs 4 and 6). Some small desiccation cracks were observed near the southeast corner of the interior slope. There were also some small sloughs observed well above the crest elevation on the excavated portion of the south embankment interior slope. On the south embankment, it appeared that the water level was below the natural ground surface elevation. The interior slopes appeared to be in generally good condition (Photographs 6, 9 and 10).

4. South Bottom Ash Pond - East embankment interior slope,
looking south

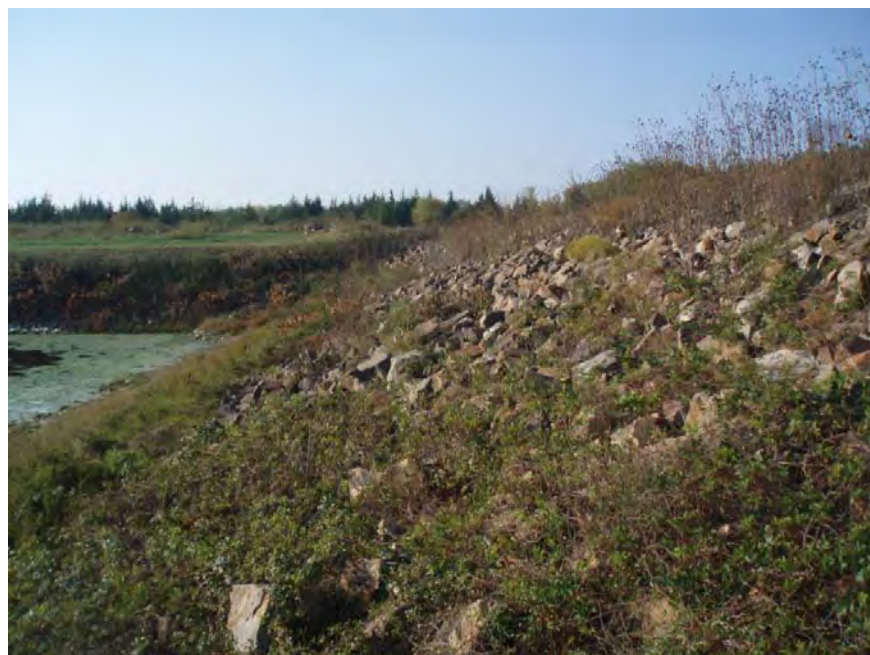
The exterior slopes of the embankments were inclined at approximately 2H: 1V. . Large riprap, approximately 2 feet in largest dimension, was observed on the face of the east embankment (Photograph 5). The slopes appeared to be in good condition.

5. South Bottom Ash Pond – East embankment slope, looking south

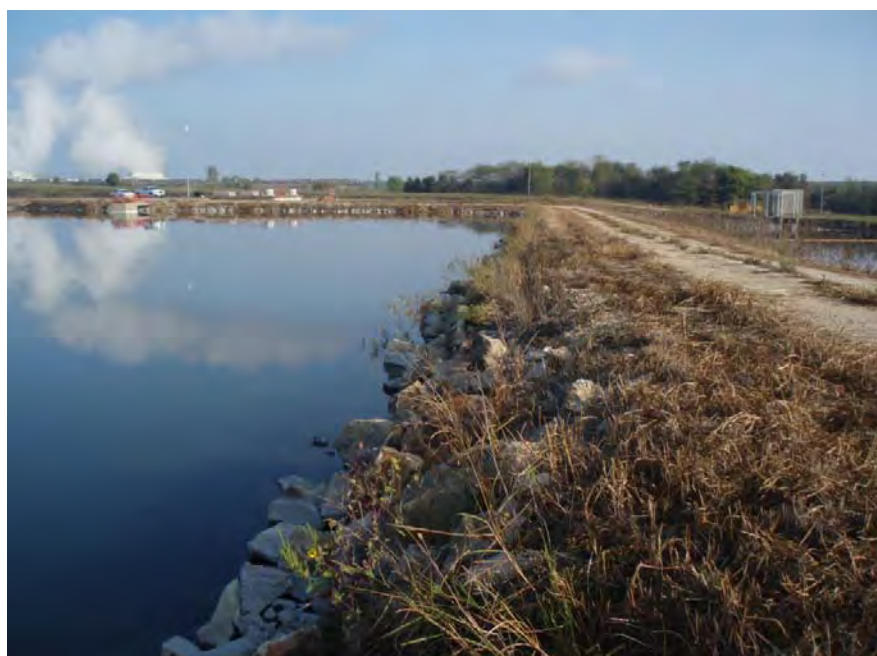
6. South Bottom Ash Pond – East embankment interior slope,
looking north

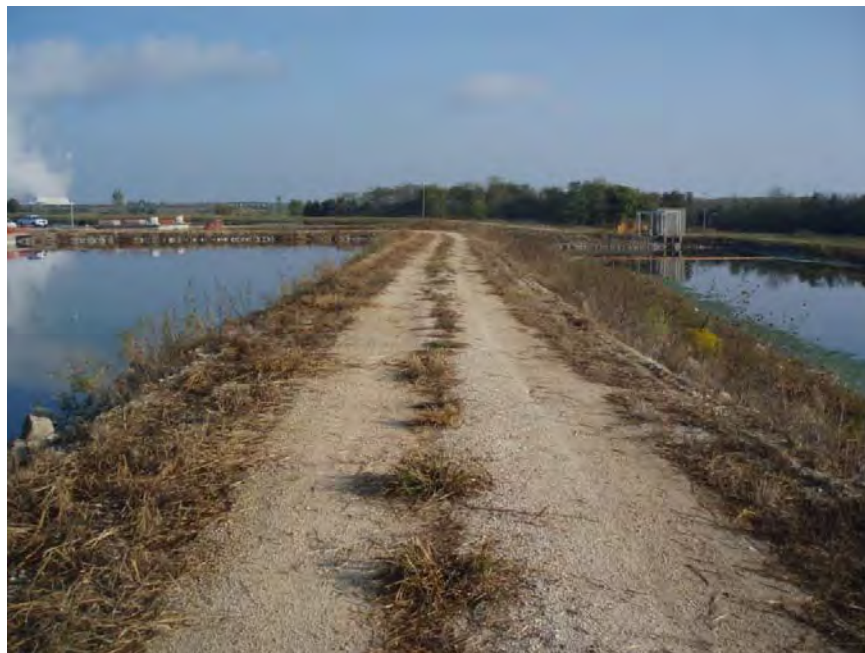
7. South Bottom Ash Pond – East embankment crest, looking north

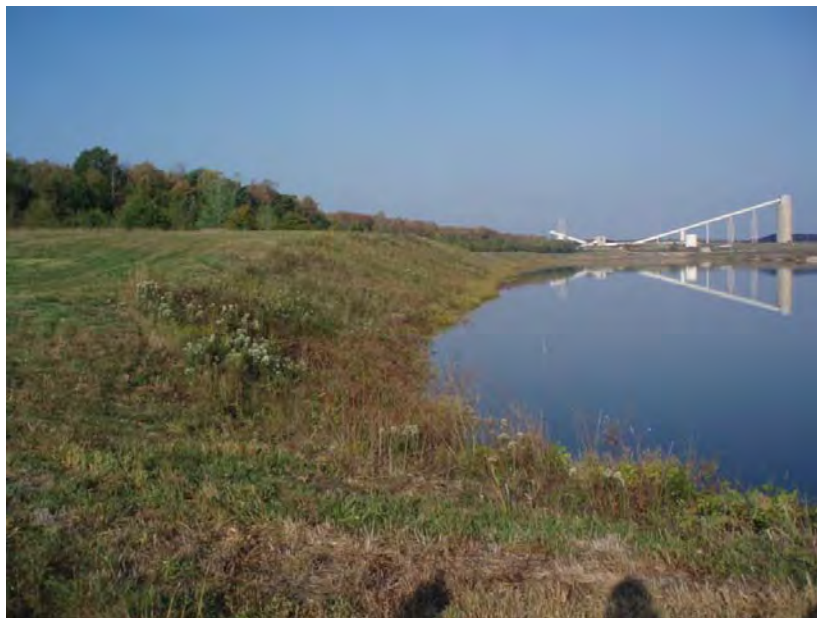
9. South Bottom Ash Pond – Southeast embankment interior slope, looking west

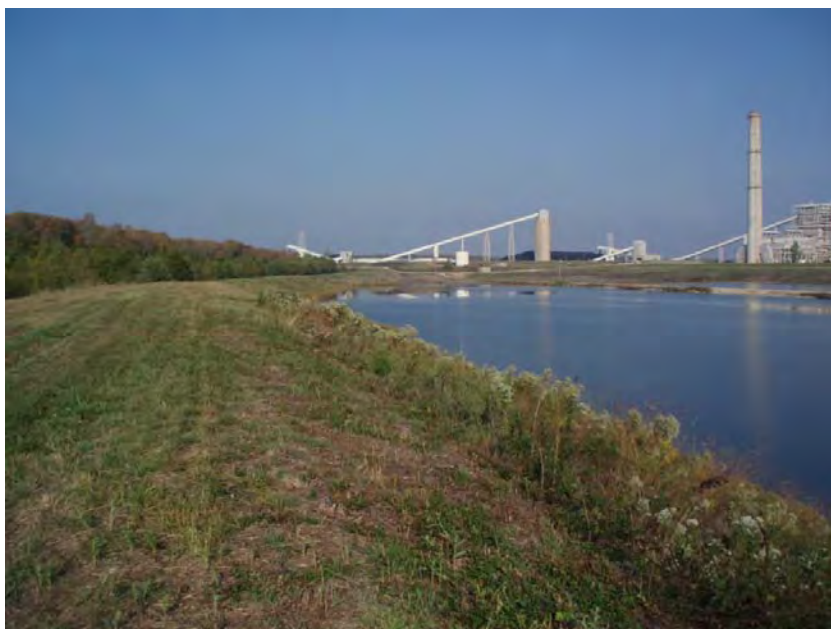
10. South Bottom Ash Pond – South embankment crest, looking west

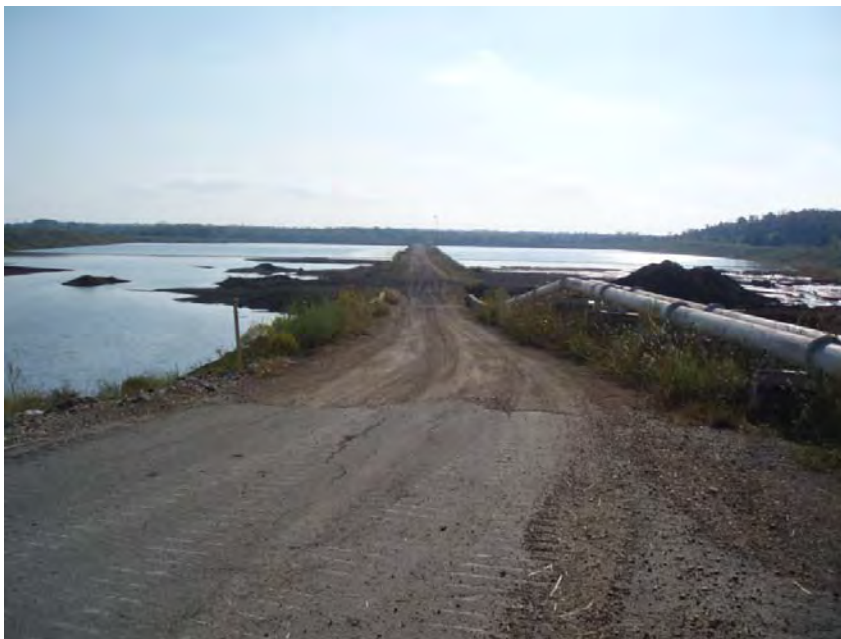
The crest of the North Bottom Ash Pond appeared to be in good condition (Photographs 13, 14, and 16). A small 3-foot by 3-foot rut was observed on the east embankment crest. The crest width ranged from about 10 feet wide along the west, north, and east embankments, and 25 feet for the south embankment. The entire crest is subjected to vehicle traffic, but most of the traffic occurs along the north and south embankment crests. The crest surface appeared to mainly consist of compacted granular material and grass.

The south embankment of the North Bottom Ash Pond is the divider between the North and South Bottom Ash Ponds. The embankment was in satisfactory condition and was covered in light vegetation (Photographs 13, 21, and 22). The vegetation was about 6 to 12 inches high. The embankment slopes appeared to be 2H: 1V. Minor sloughing, cracks approximately 15 feet long (Photograph 21), and ruts were observed in some localized areas of the divider embankment. The sloughs observed did not

13. North and South Bottom Ash Pond Divider Embankment- West end of crest, looking east

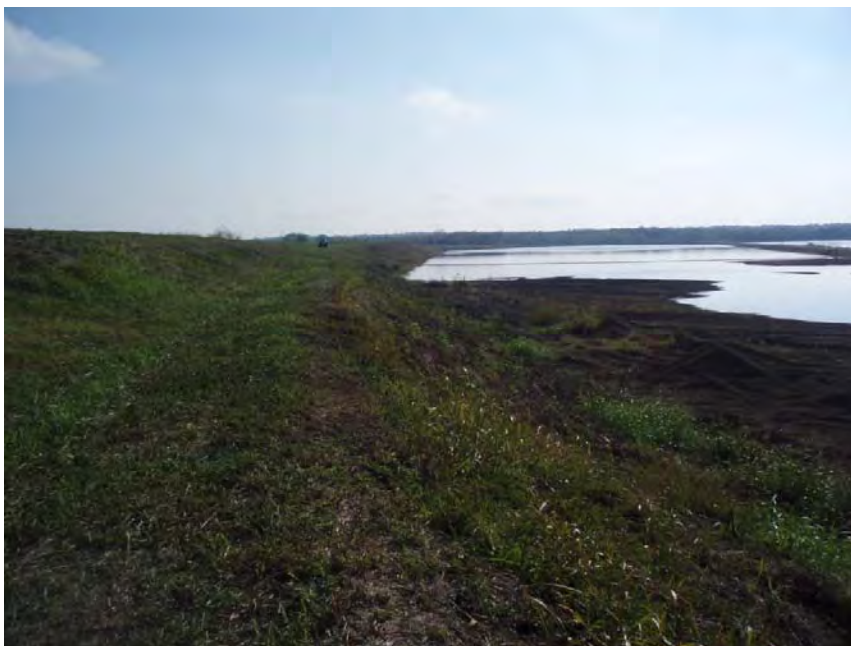
The interior slopes appeared to be in good condition. Light vegetation covered the embankment interior slopes (Photographs 14, 15 and 16). The interior slopes appeared to be approximately 2H: 1V. No armoring of the interior slope was observed, and no significant erosion or slumping was observed.

14. North Bottom Ash Pond - North embankment interior slope, looking east

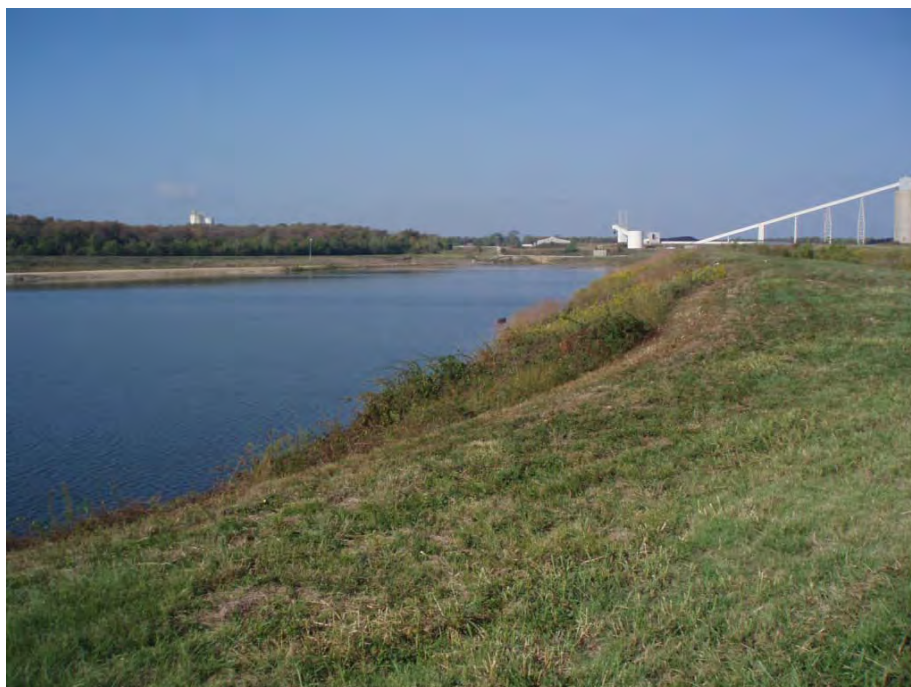
15. North Bottom Ash Pond – North embankment interior slope, looking west

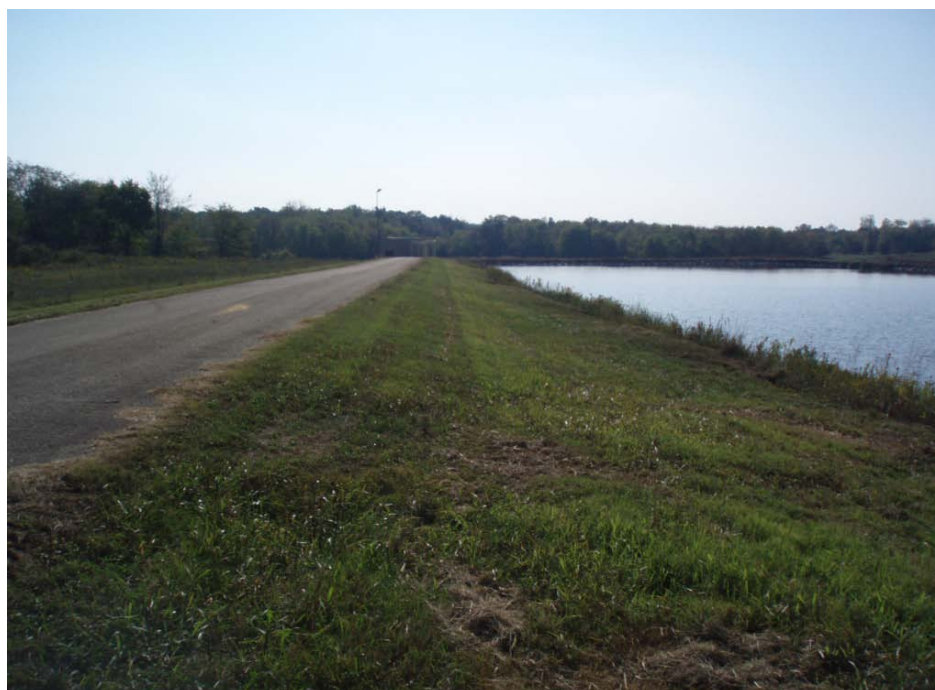
16. North Bottom Ash Pond – East embankment crest and interior slope, looking southeast

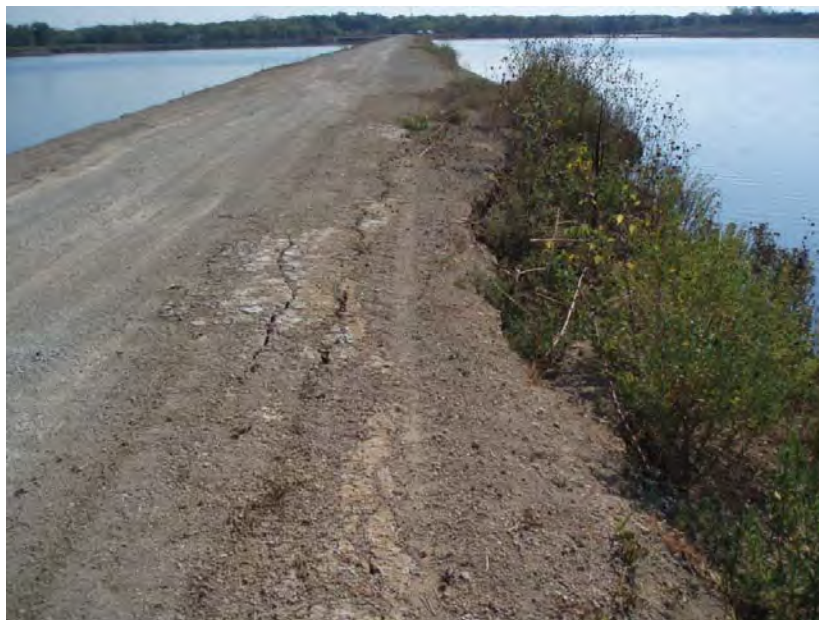
21. Bottom Ash Ponds – Longitudinal cracks along divider embankment, looking east

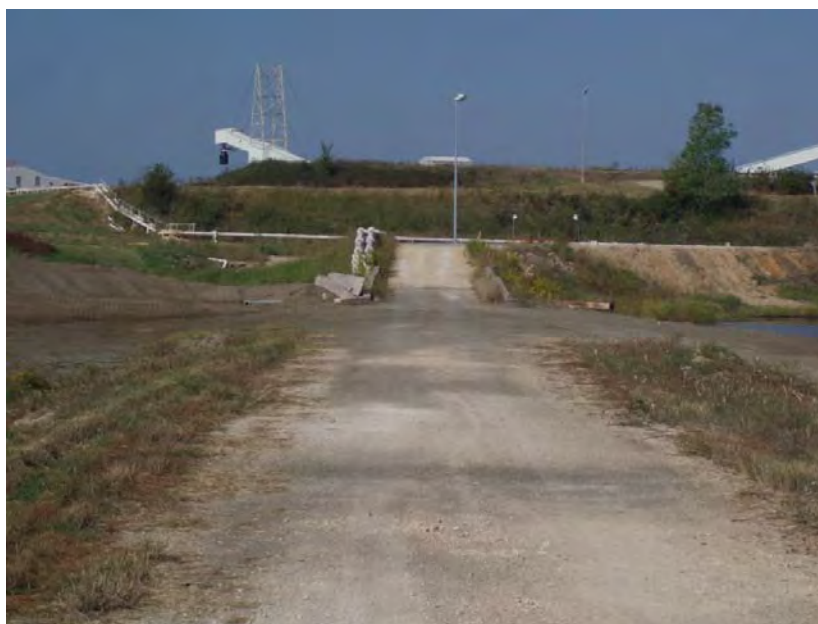
22. Bottom Ash Ponds – Discharge outlets on either side of the divider embankment, looking west

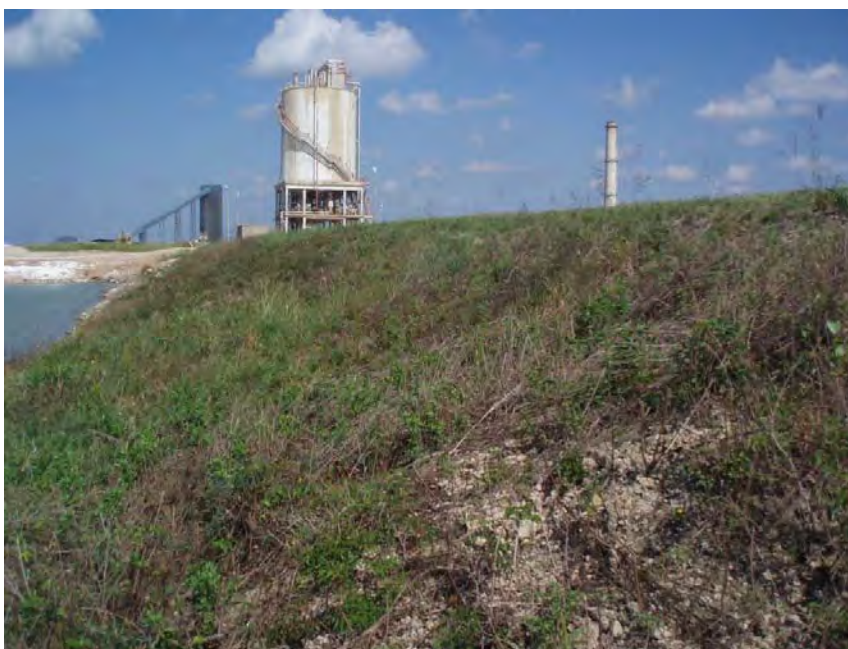
The slopes were 2H: 1V, except in the areas where sloughing and resulting oversteepening of the interior face occurred. Sloughing was observed on the southern portion of the east embankment (Photograph 26) and at the western end of the south embankment interior slope (Photograph 34). In those areas slopes appear to be approximately 1H: 1V. Vegetation, consisting primarily of grass and brush less than 6 inches tall was observed on the interior slopes of the west, east and north embankments. There were also some small areas where vegetation was observed to be sparse. The interior slopes appeared to be generally in fair condition (Photograph 46).

26. South Fly Ash Pond – Sloughing on east embankment interior slope, looking north

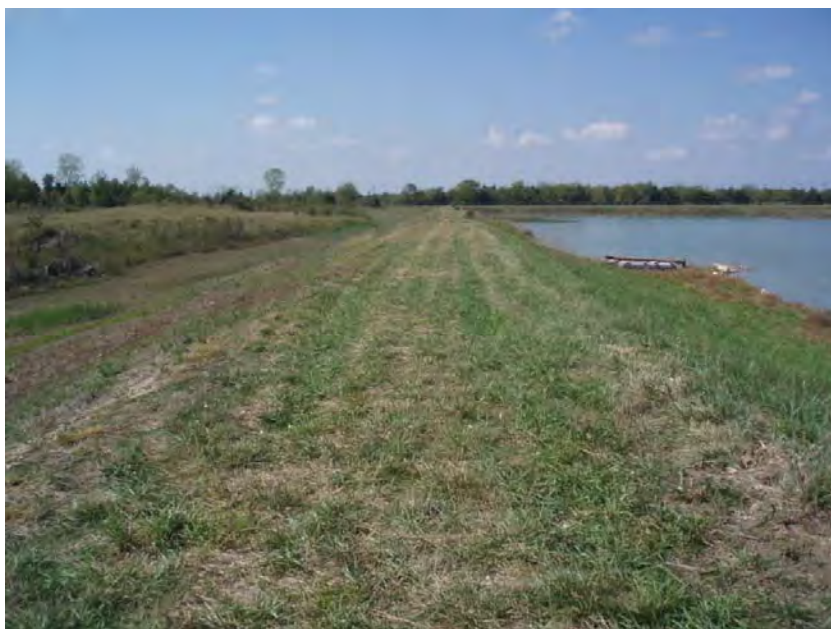
The average crest width of the north embankment is approximately 25 feet. The average crest width of the west, south and east embankment was approximately 10 feet. The crest surface consisted of compacted granular fill materials or was vegetated. A minor depression approximately 30 feet long by 12 feet wide was observed on the south embankment crest (Photograph 32). The crest generally appeared to be in good condition (Photograph 28) with the exception of rutting.

28. South Fly Ash Pond – South embankment exterior of southeast corner, looking west

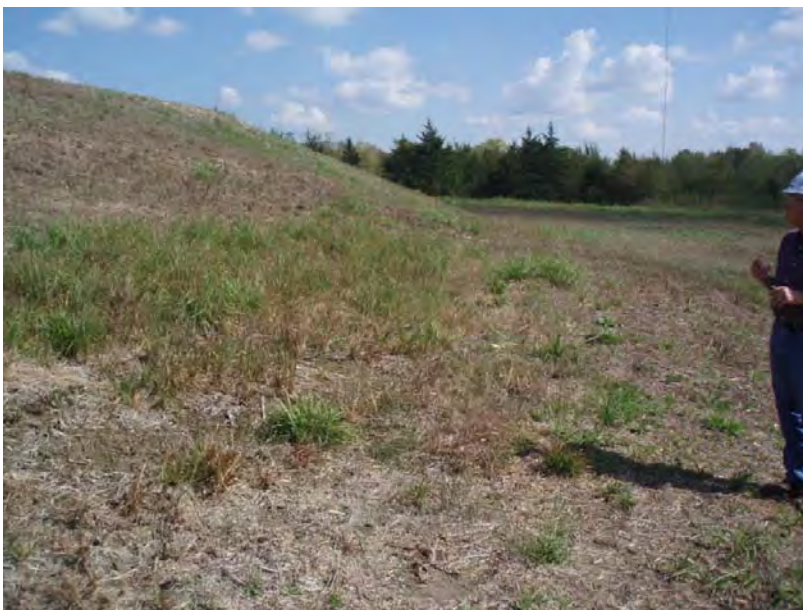
The west, north, and east exterior slopes appeared to be in good condition. The south exterior slope appeared to be in poor condition. An approximate 15-foot by 90-foot wet area was observed on the south embankment (Photograph 29). Near the south east corner of the embankment, an approximate 24-foot by 60-foot area of cattails was observed (Photograph 30). A 75-foot-long portion of the south embankment slope appeared to be over-steepened and eroded, with some signs of possible slope movement (Photograph 31). Another 75-foot-long slough was observed on the south embankment (Photograph 33).

29. South Fly Ash Pond – Wet area on south embankment exterior slope, looking east

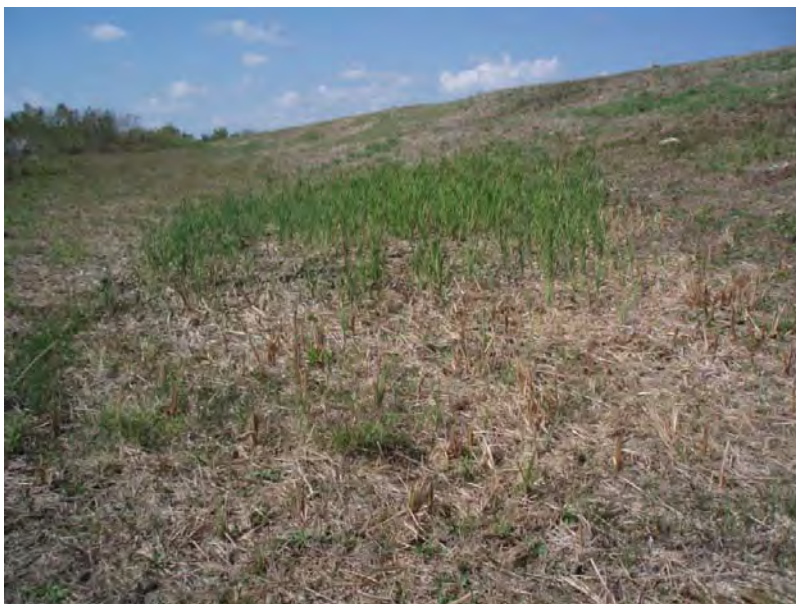
30. South Fly Ash Pond – Cattails growing on south embankment exterior face, looking west

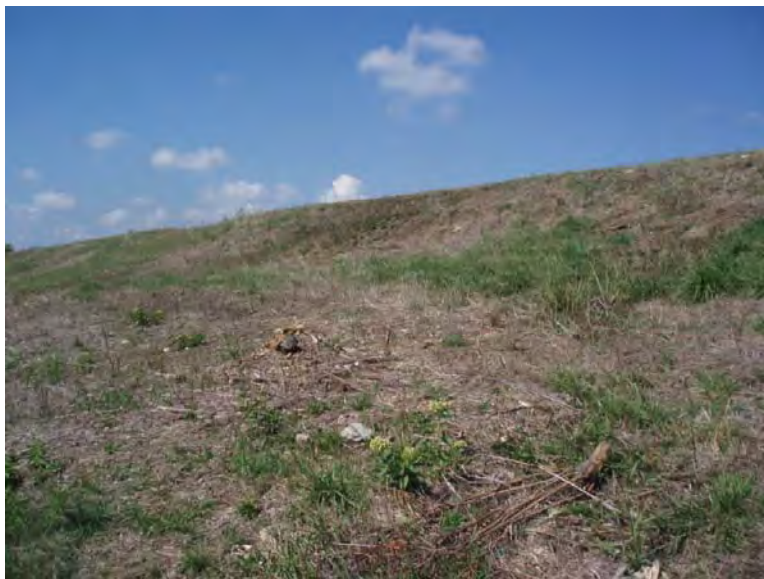
31. South Fly Ash Pond – South embankment exterior face slough, looking northwest

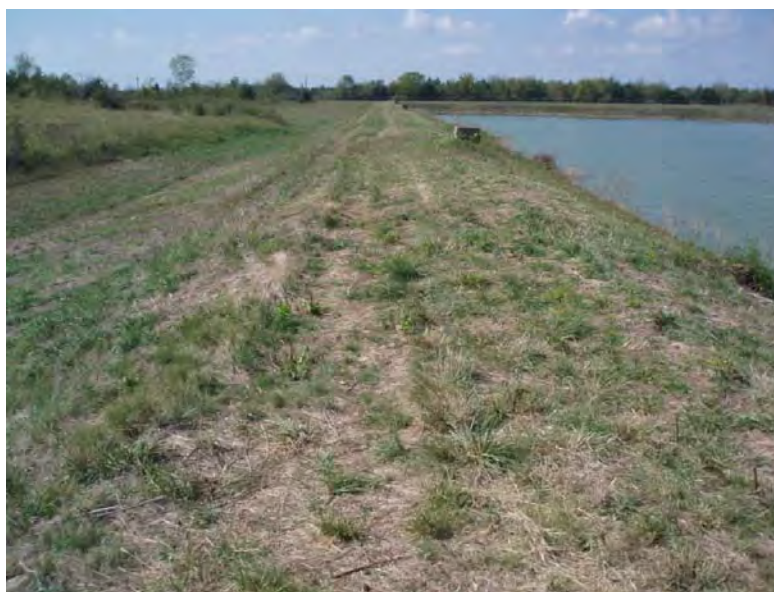
32. South Fly Ash Pond – South embankment crest depression, looking west

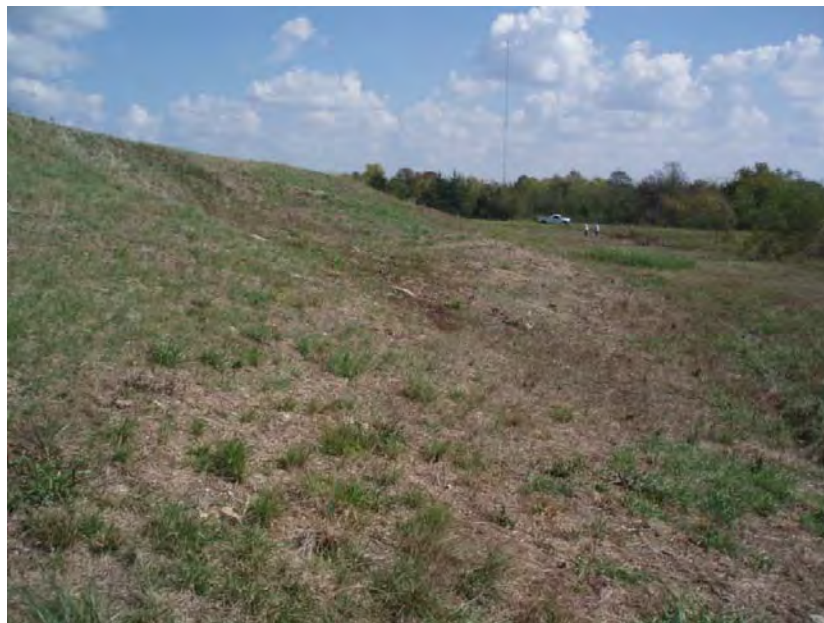
33. South Fly Ash Pond – South embankment exterior slope slough, looking east

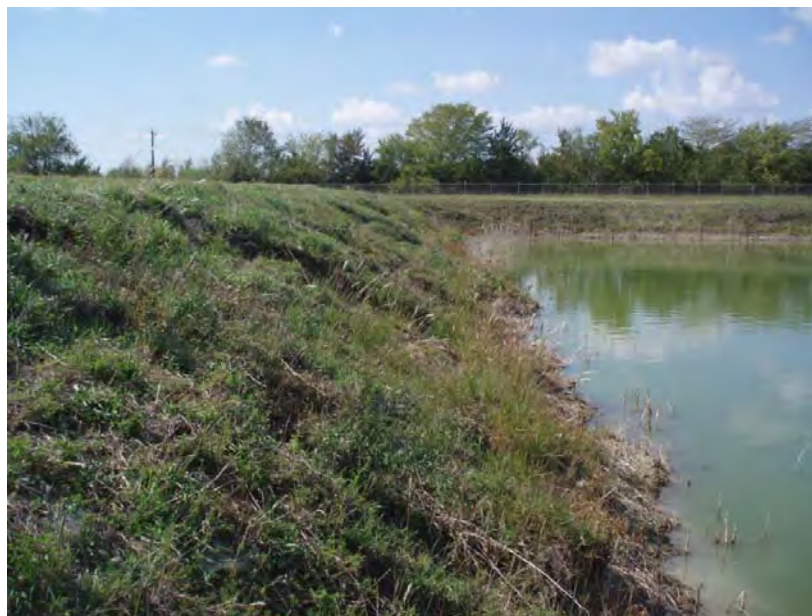
34. South Fly Ash Pond – South embankment interior slope slough, looking west

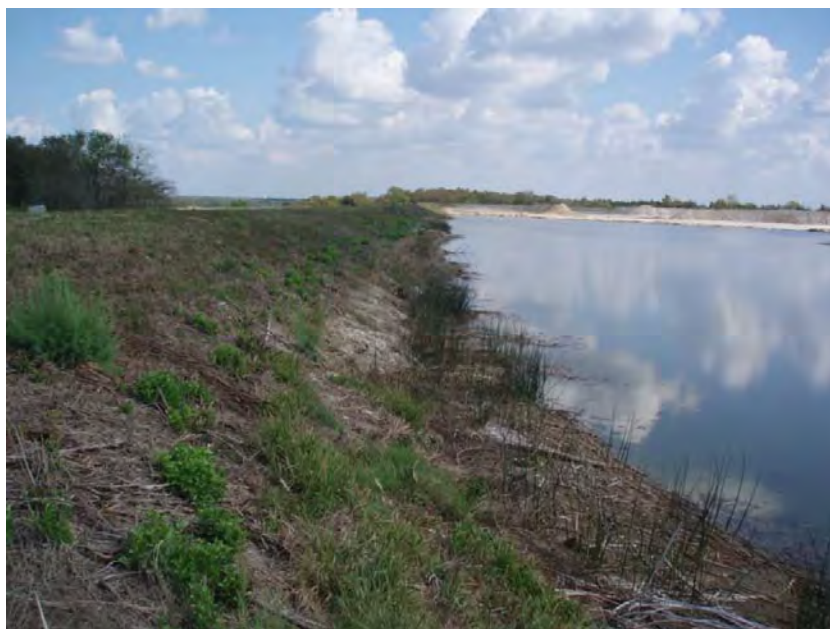
The interior slopes were generally inclined at 2H: 1V. In general the surface of the interior slopes had areas of sparse and light vegetation up to one foot high (Photograph 38). Some small stumps, small-diameter woody growth, and minor surface erosion were observed on the west embankment interior slope. Minor over-steepening of the interior slope was observed in some areas, apparently the result of erosion. Vegetation had been removed from portions of the north and south interior slopes, most likely due to ash excavation (Photographs 42 and 48). Several sloughs (Photographs 40 and 41) were observed along the north embankment. On the north embankment slope, four sloughs were estimated to be 75, 35, 65, and 60 feet long, respectively. In the slough areas, the upper portion of the embankment appeared to be over-steepened to about approximately 1H: 1V. The interior slopes appeared to be in fair condition.

38. North Fly Ash Pond – Northwest embankment corner interior slope, looking east

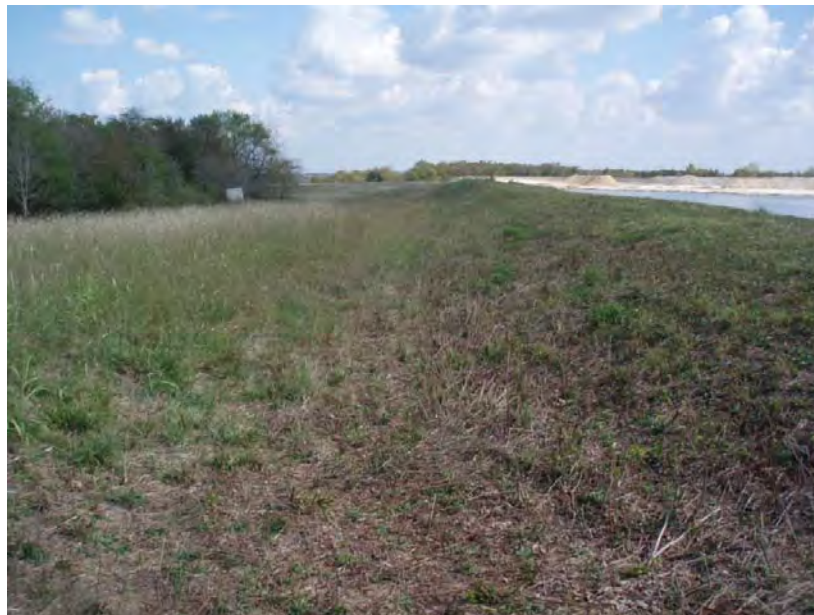
The embankment exterior slopes were approximately 2H: 1V. The slopes were covered with light vegetation about 6 to 8 inches high (Photograph 39) with the exception of the east embankment. On the east embankment there were some areas of Johnson grass that was about 3 feet high. An area that was identified by plant personnel as being seasonally wet that was dry at the time of the site visit and some sparse vegetation were observed on the northeast corner of the embankment (Photograph 43). No significant erosion features were observed on the slopes. The exterior slopes appeared to be in good to fair condition.

39. North Fly Ash Pond – Northwest embankment corner exterior slope, looking east

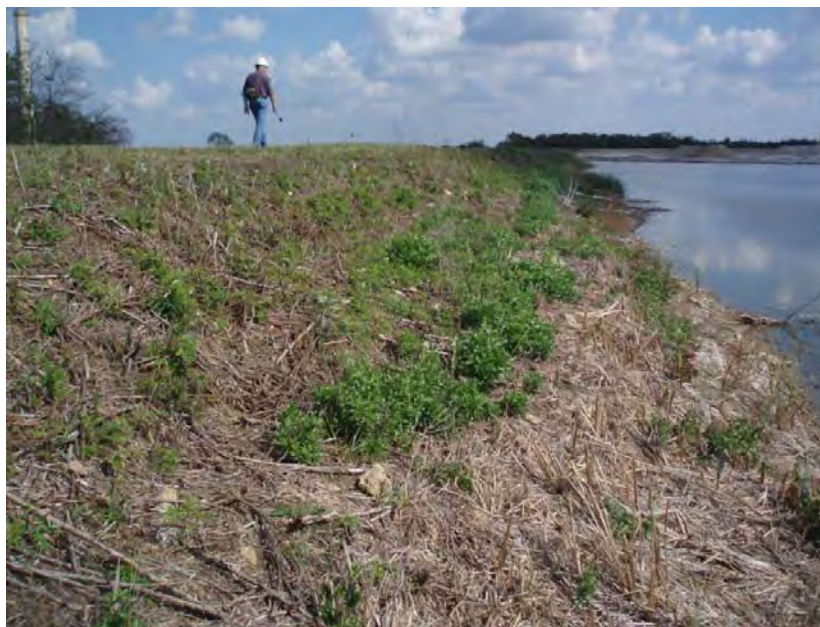
40. North Fly Ash Pond – North embankment interior slope slough, looking east

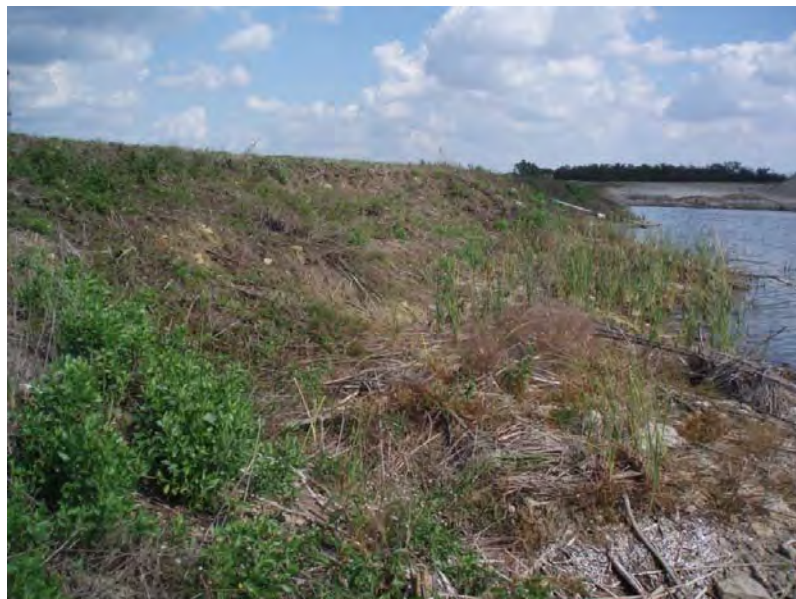
41. North Fly Ash Pond – North embankment interior slope slough, looking east

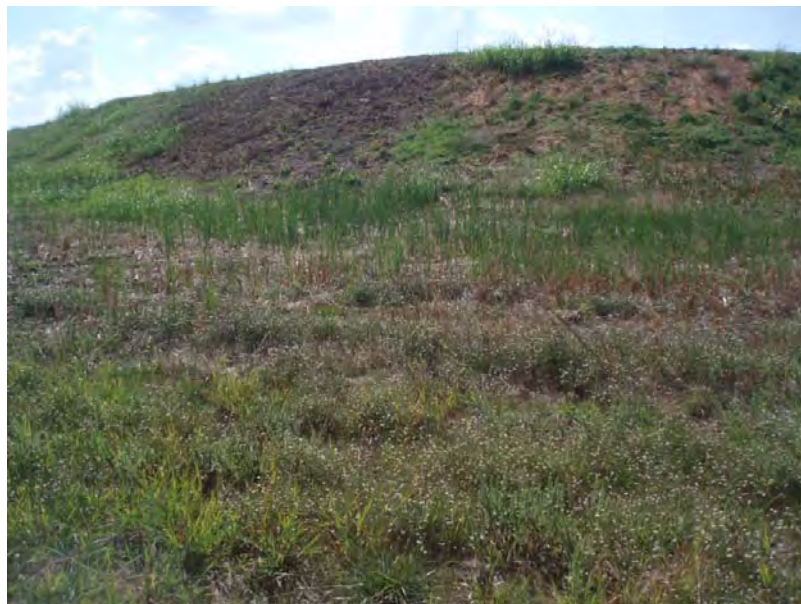
43. North Fly Ash Pond – Northeast embankment corner exterior slope seasonal wet area

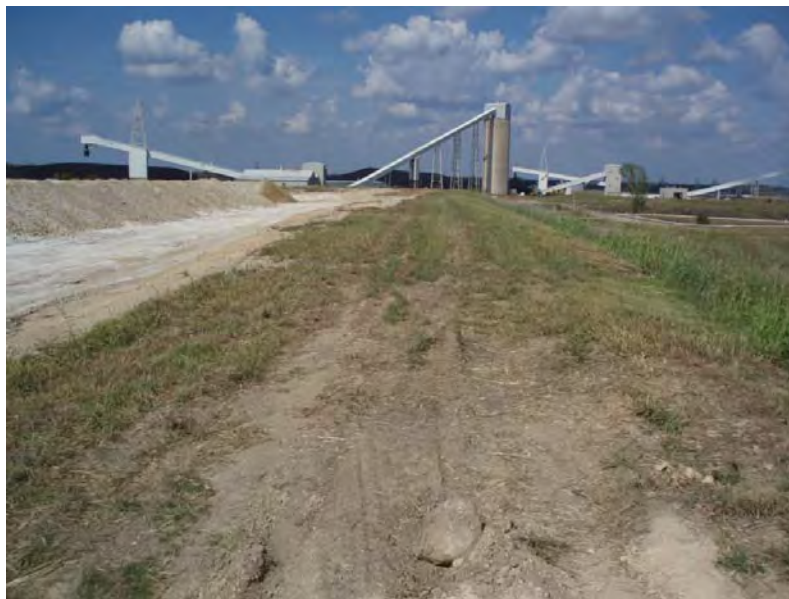
The average width of the embankment crest was 10 feet, with the south embankment crest being up to about 25 feet wide. In general, there were no signs of misalignment. The crest is utilized for vehicle access. A portion of the east embankment crest, near the northeast corner, had rutting from vehicle traffic (Photograph 44). The crest appeared to be in fair condition.

44. North Fly Ash Pond – West embankment crest vehicle ruts, looking north

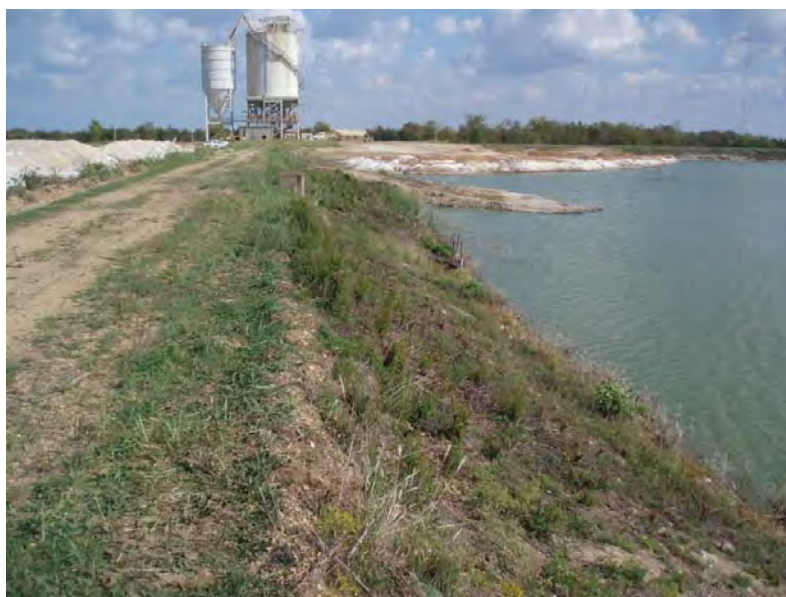
46. Fly Ash Pond Divider Embankment– Central portion of south interior slope, looking east

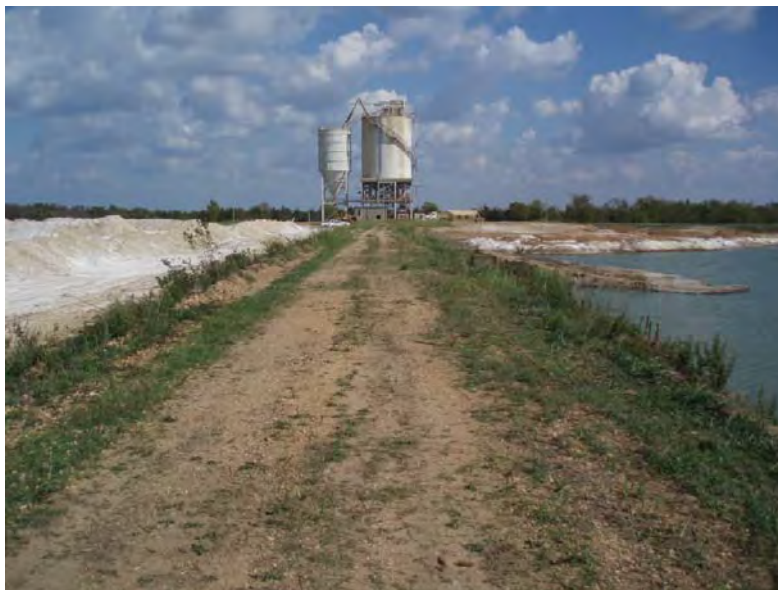
The south embankment serves as the divider embankment between the north and south fly ash ponds. In general, there were no signs of misalignment (Photographs 47 and 48). The divider embankment crest is utilized for vehicle access. An apparent slough approximately 130-foot-long that extended from the crest to the water level was observed on the south side of the divider embankment. The interior slopes appeared to be in fair condition.

47. Fly Ash Pond Divider Embankment- Central portion of crest and interior slope, looking east

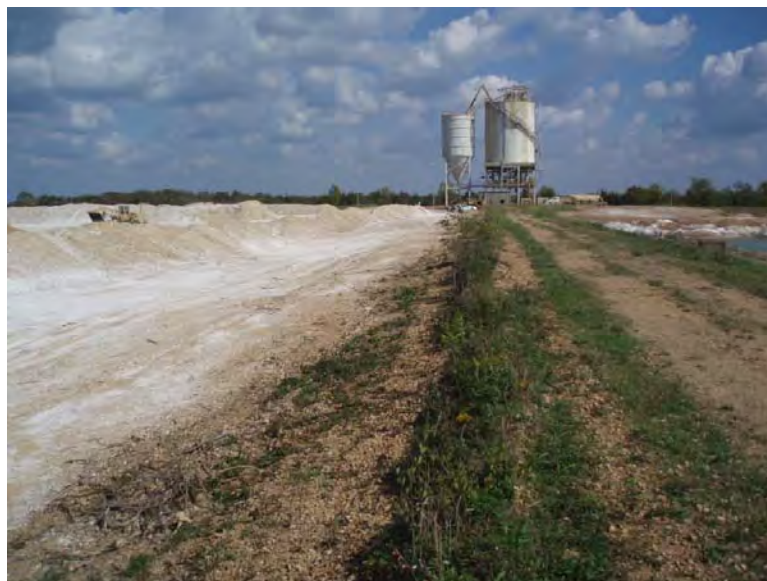
48. Fly Ash Pond Divider Embankment- Central portion of north exterior slope, looking east
